# Ultrasonic inspection technology

Stephen R Cox and David A Harman, SGS PfiNDE, Inc., USA, discuss the use of ultrasonics for measuring sludge and sediment levels in pipelines.

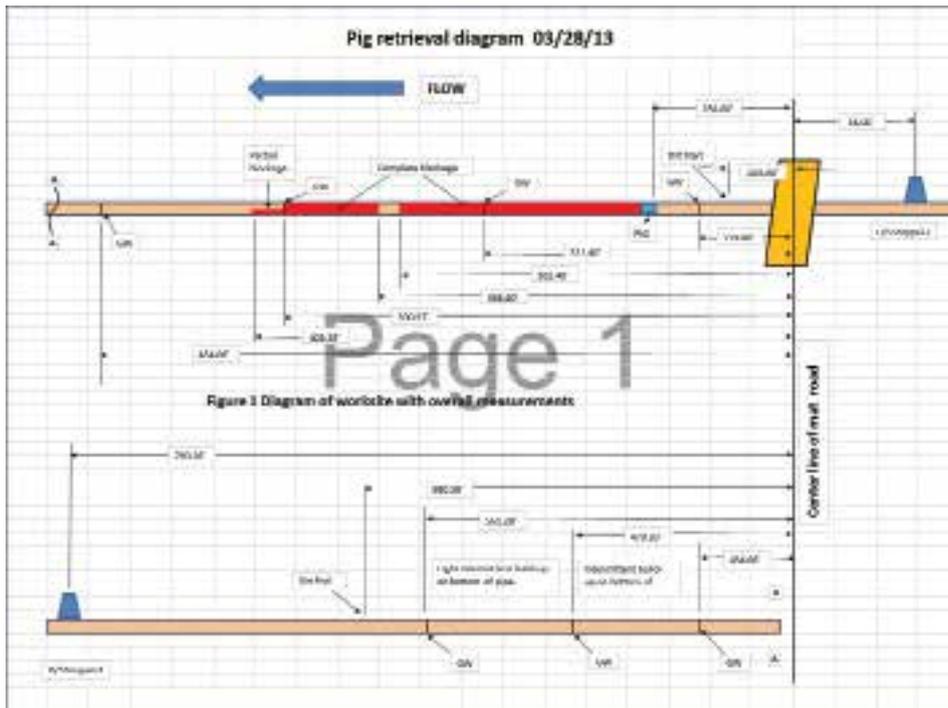
Figure 1. Diagram of worksite with overall measurements.

secondly, they needed to know the location of the blockage in relation to the stopple tees; and thirdly, they needed to isolate and contain the sediment, determine the sludge level and ensure that the tool could not only be removed, but that when the line was put back in service, the company would have no further issues with flow. The diagram shown in Figure 1 was created by SGS technicians in the field as part of the final report.

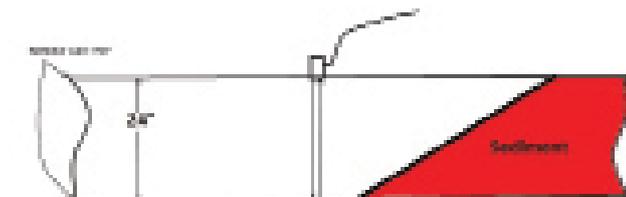
Figure 2. Use of ultrasonics to verify liquid levels and locate large deposits of particulate or sediment.

Ultrasonic inspection technologies require only a single technician with minimal equipment – results are displayed in microseconds, are readily available for interpretation and the technology does not pose a safety hazard. Radiographic imaging requires multiple personnel with extensive equipment requirements, takes several minutes for each shot along multiple-foot sections of the pipeline (with additional time required for film development prior to interpretation of the results) and poses a safety hazard to all nearby personnel. Since the transducer can transmit and receive sound through the entire volume of materials, with an ultrasonic inspection system, a single transducer is connected to the ultrasonic instrument and is used to take measurements from any location with access to the outside surface on the circumference of the pipe (Figure 2).

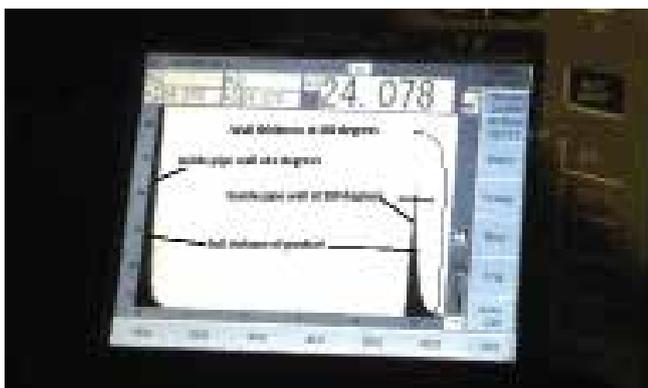
Figure 3. Description of screen signals.

When inducing sound into the top of the pipe, at a location upstream of the impacted pigging tool that was clear of sediment, the technician was able to transmit ultrasonic signals through the wall thickness of pipe and the entire volume of product in the line, and receive a return signal from the bottom of the inside pipe wall (180°). Additionally, the technician was able to transmit ultrasonic signals through the entire volume of the bottom wall thickness (Figures 3 and 4).

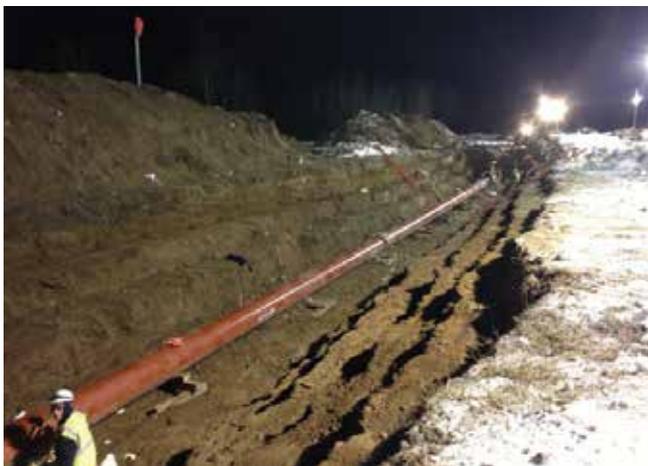
Figure 5. 150' of pipeline removed from service due to sediment levels.

After final interpretation of the inspection results, it was determined that approximately 150 ft of pipeline was solidly impacted with sediment buildup (Figure 5). Based on the results, the pipeline company was able to develop a strategy to effectively and efficiently cut and remove the specific section of the impacted pipeline (Figure 6).

The repair plan, developed as a result of the ultrasonic inspection data collected, permitted the removal of the pipeline section containing the blockage and the impacted pigging tool well within the stopple tees, thereby stopping the flow of the liquid product before the operation. Additionally, the pipeline company was able to remove all of the sediment blockage and buildup, reducing any further issues that may have resulted from partial removal, while at the same time preventing any product leakage that would have posed serious environmental issues. Finally, the removed section was replaced and after the successful completion of testing, normal pipeline operations resumed.

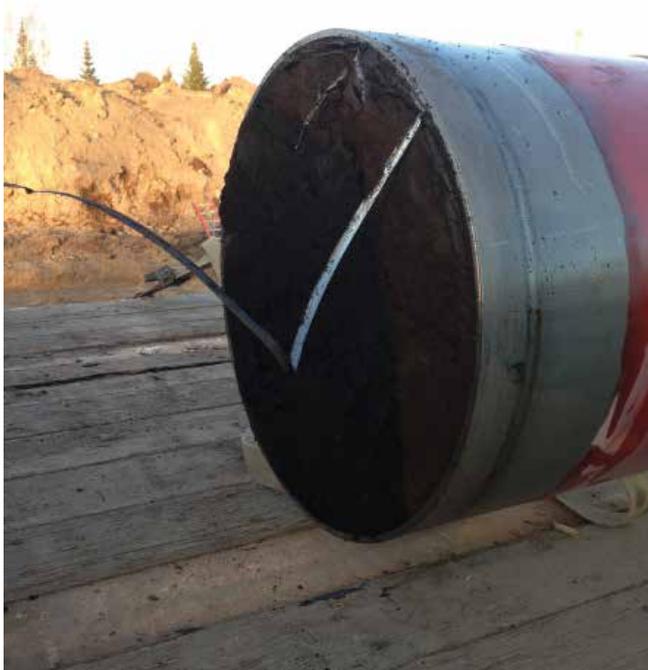
Figure 6. Cross section of pipe showing extent of blockage.
